Drone inspections go **nuclear** with GPS and RADAR

High-precision GPS receivers mounted on drones able to identify 1 mm hairline defects in cooling towers

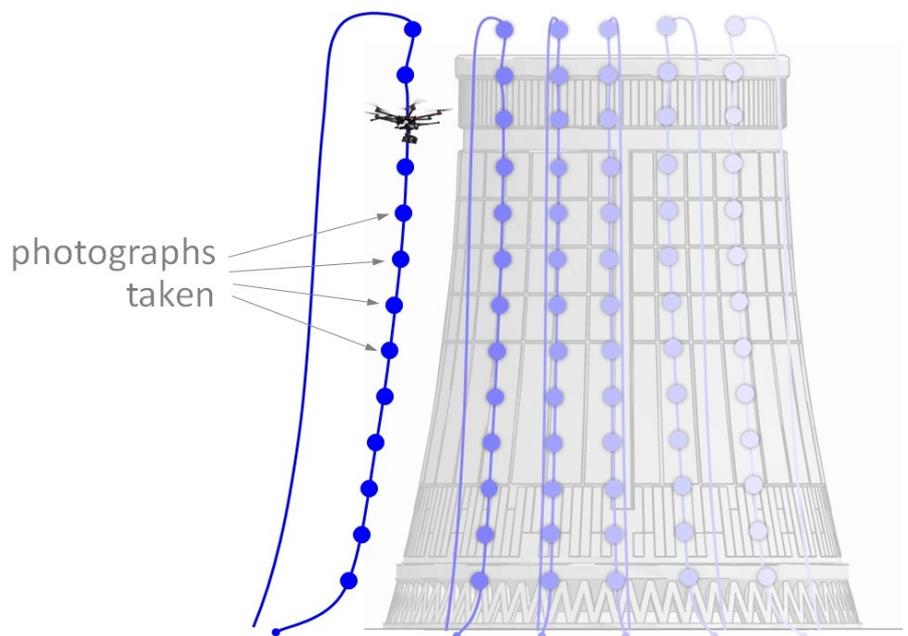
The drone was flown close to the cooling tower as shown, taking photographs at regular intervals during its descent

The drone inspection specialists Aetos Drones, were called in to carry out the inspections with none other than Lieve Van Gijssel, Belgian's first certified drone pilot, at the helm. An octocopter fitted with a high-resolution camera, a RADAR system and an AsteRx-m UAS receiver was flown vertically up and down the sides of the cooling tower whilst taking photographs at regular intervals.

The RADAR system was [AI Robot's Ranger](#), an add-on sensor specifically designed for distance detection on UAVs. The octocopter had to get close enough to the tower to get good quality images but not so close as to risk getting tossed around by the turbulence generated by the tower - a job for which the Ranger was perfectly suited.
